# Maintenance Technology of Honshu-Shikoku Bridges

-Long-span bridges for more than 200 years-

# Ageing Road Assets

# Expressway Renewal Project

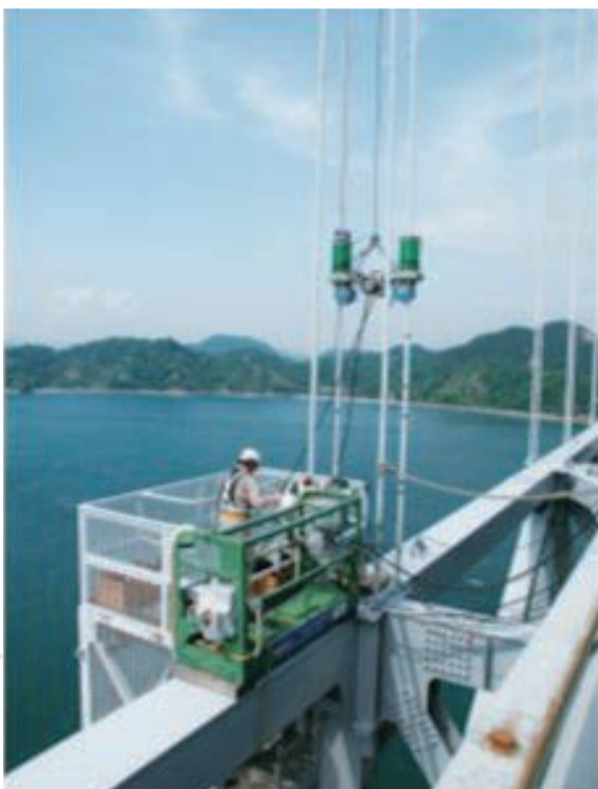
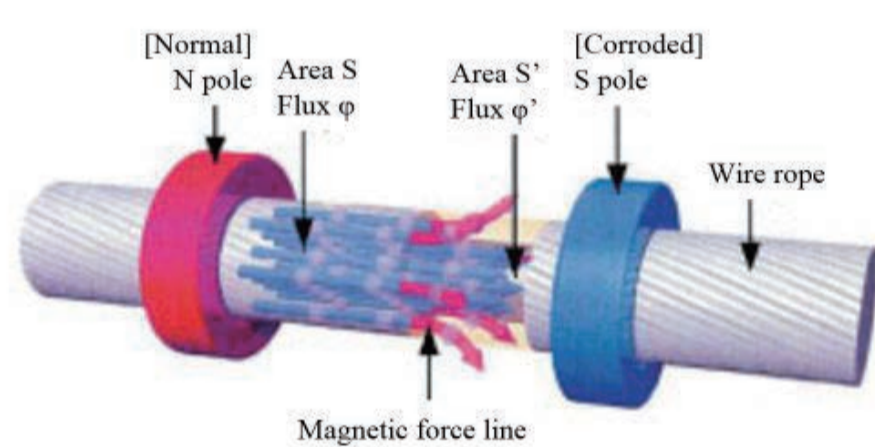
By measuring the amount of magnetic flux along the magnetized suspender rope, reduction of cross section is estimated.

Principle of Main Flux Method

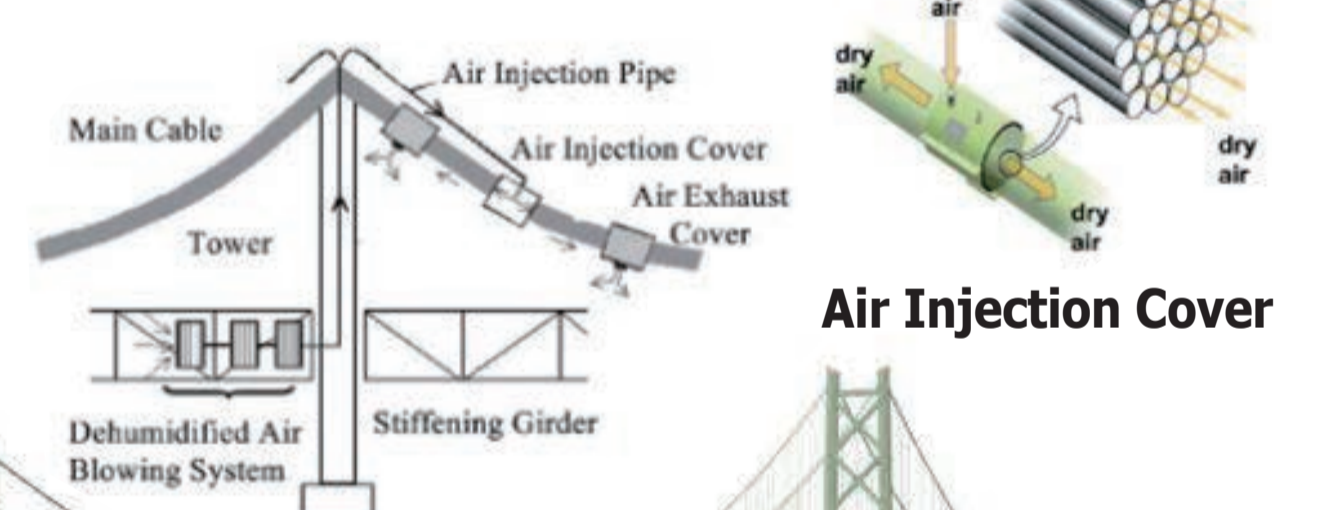
By injecting dry air into cable, corrosion of the main cable is prevented.

Air Injection Cover

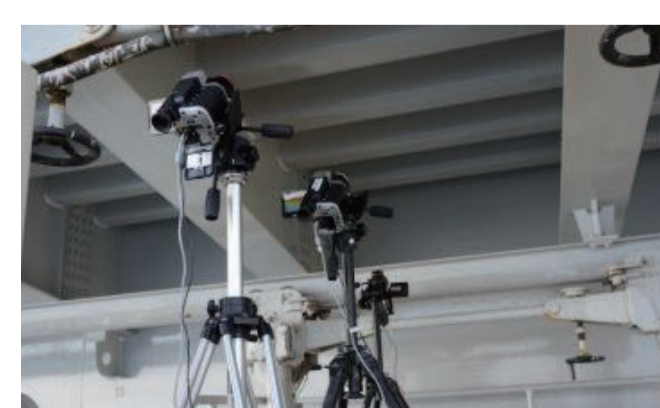
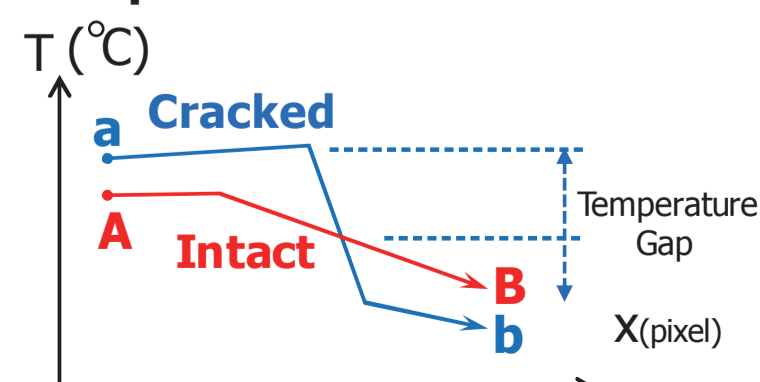
By measuring temperature gap through infrared camera, fatigue cracks in the welding connection of steel deck are detected.

Temperature Profile

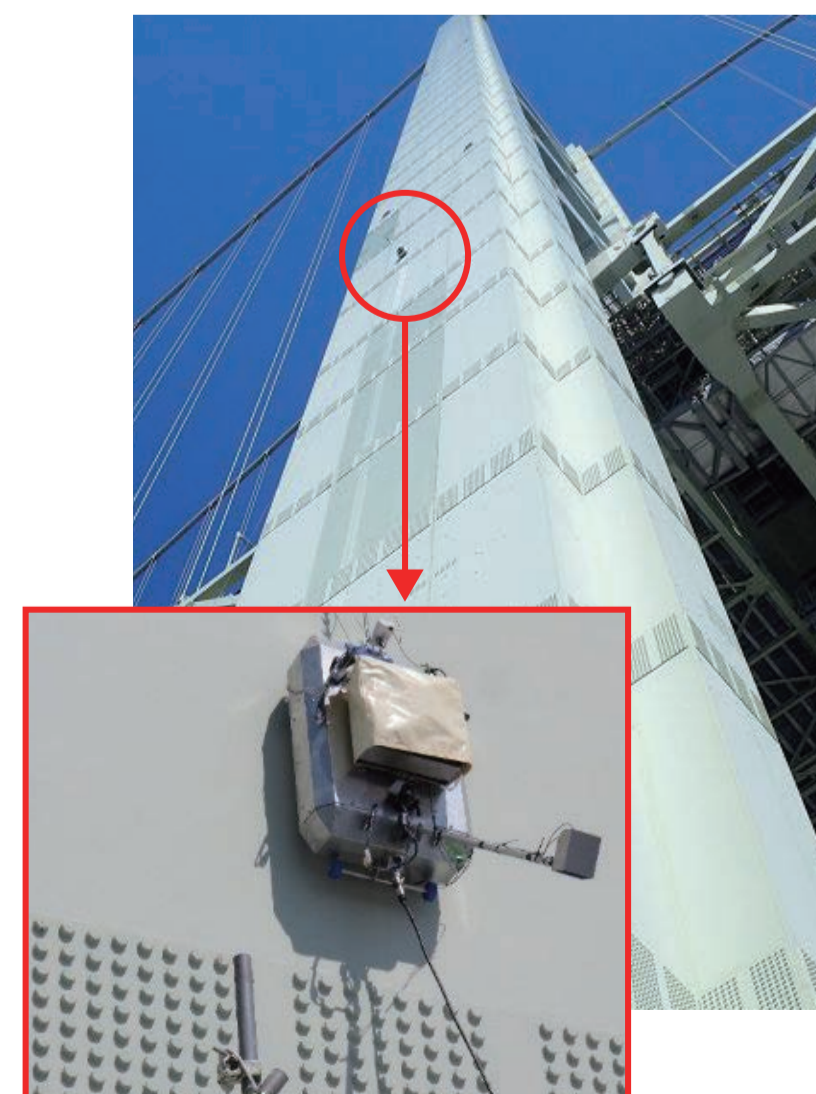
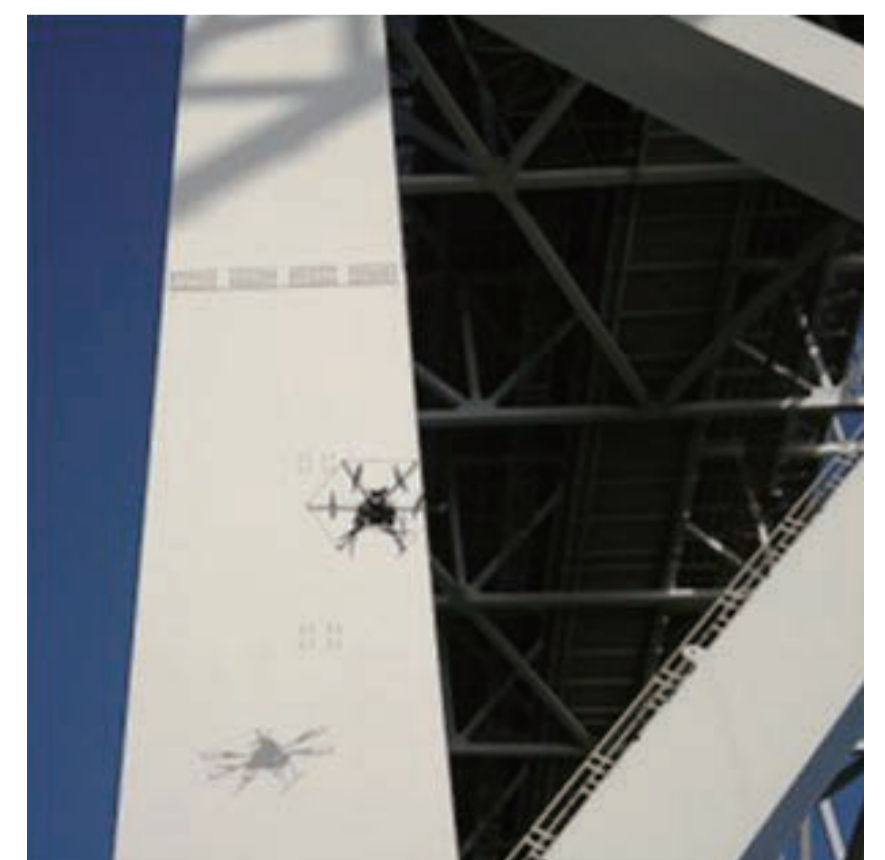
Inspection technology is being developed for efficient inspection of massive structures.

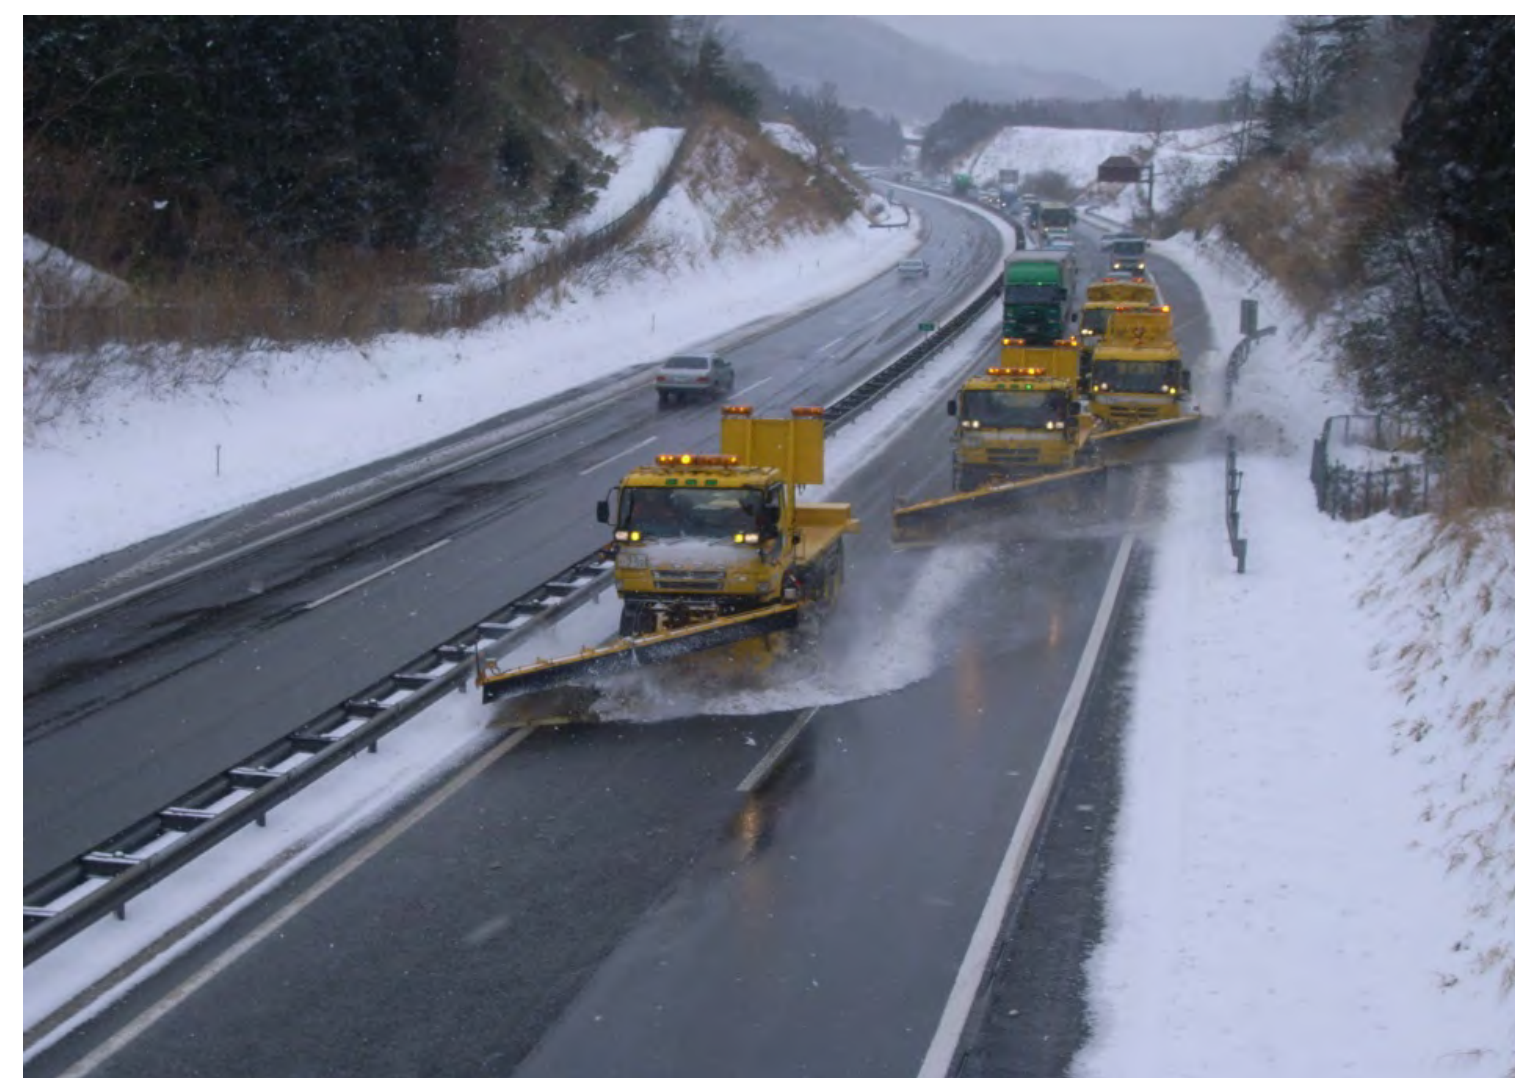
Severe environment in snow region

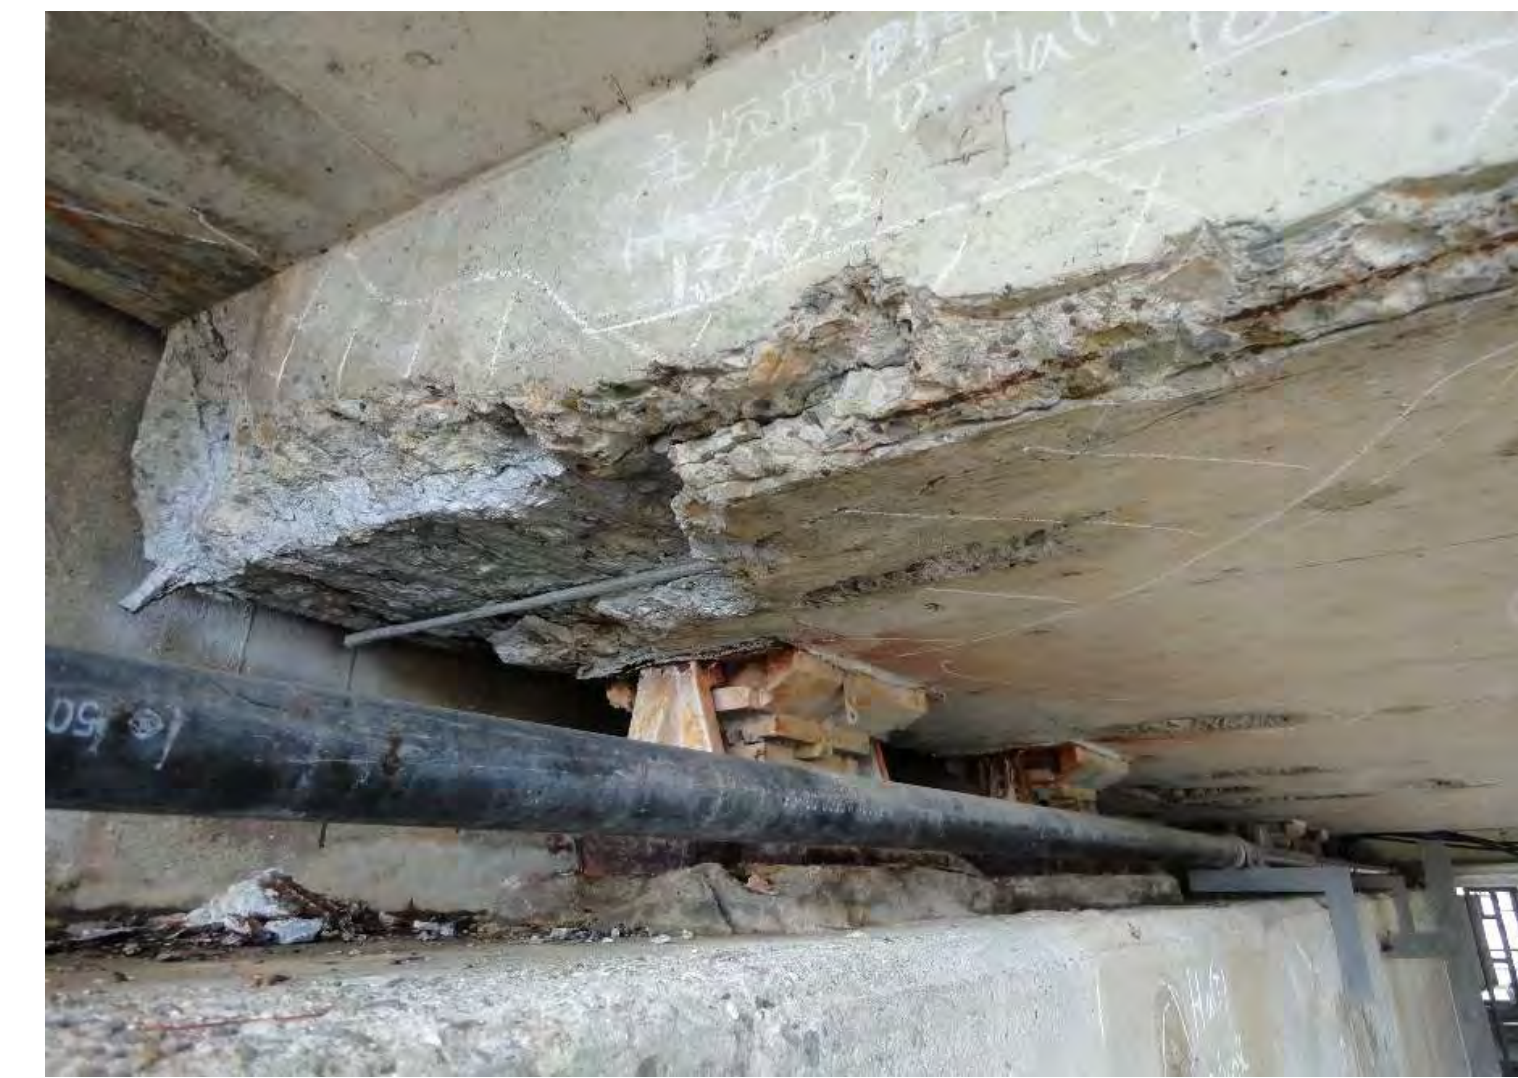
Concrete cracks and float

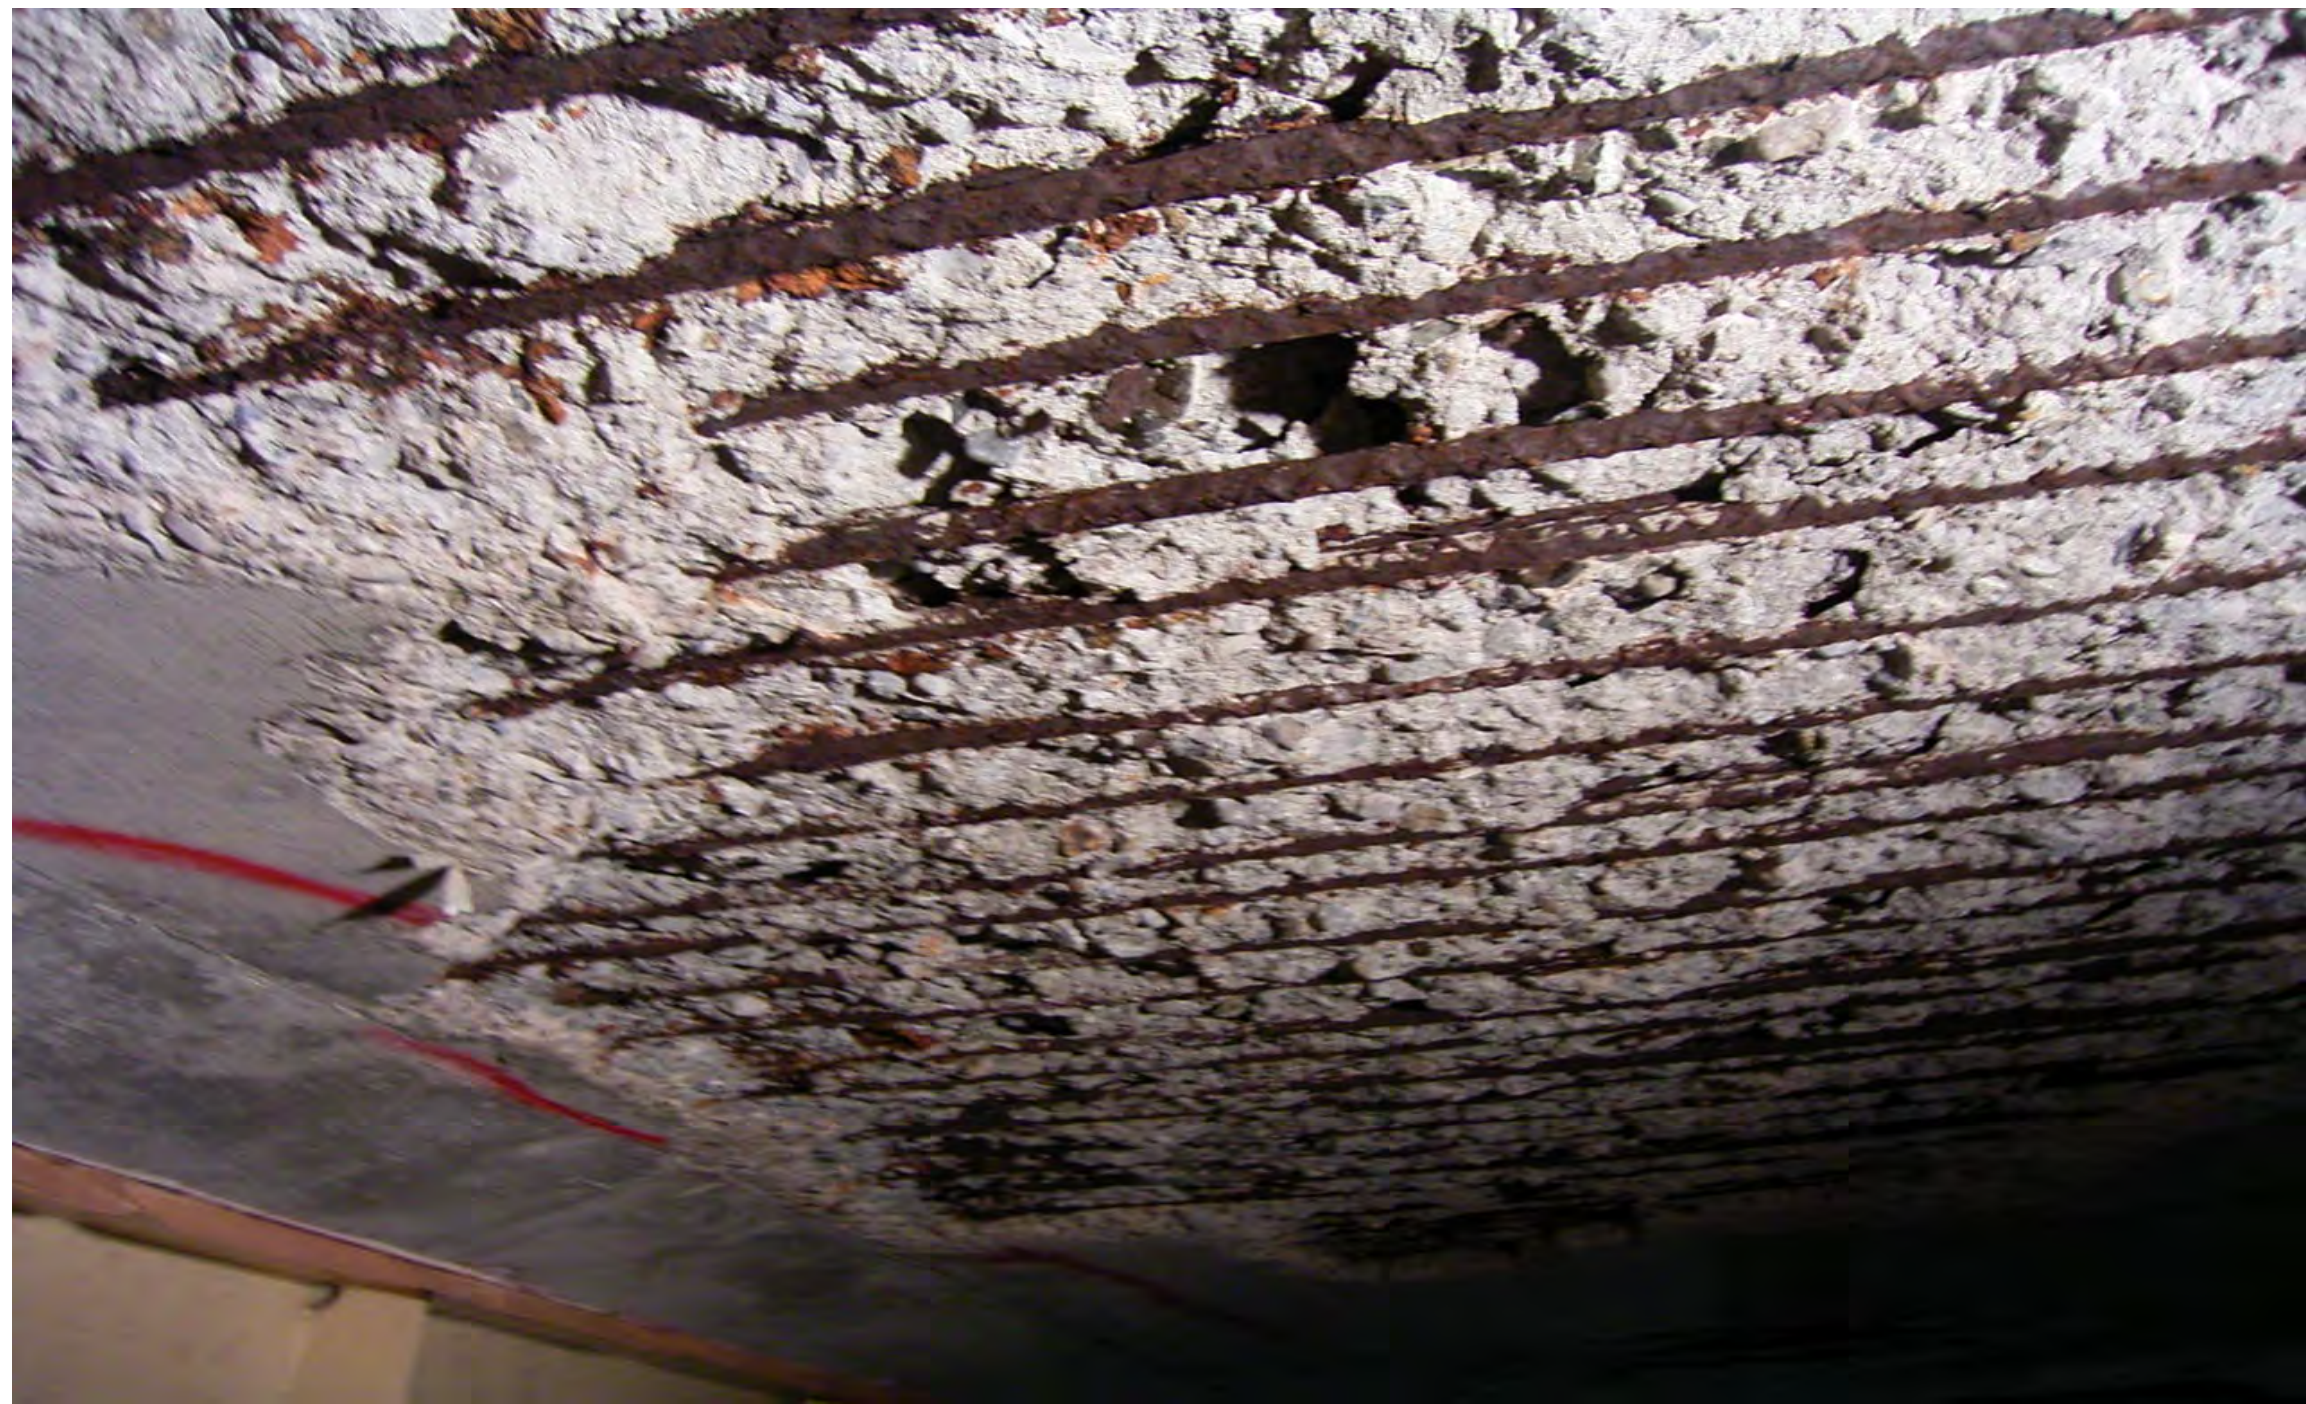
### Severe deterioration on slab lower surface

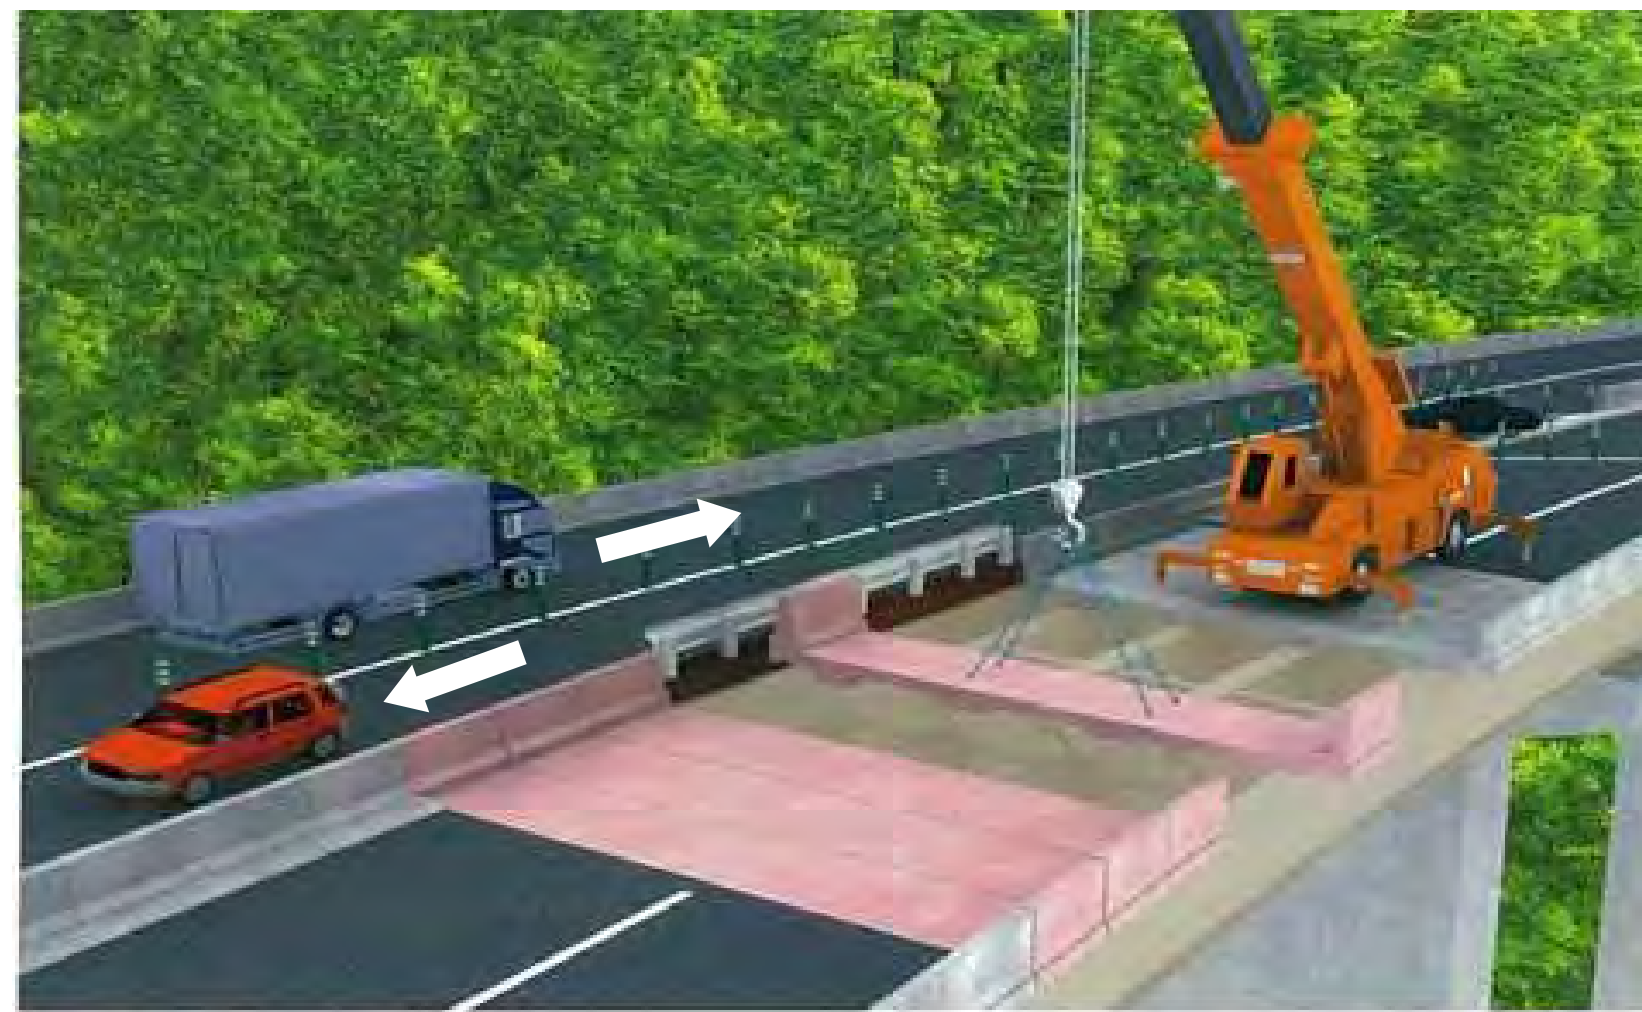
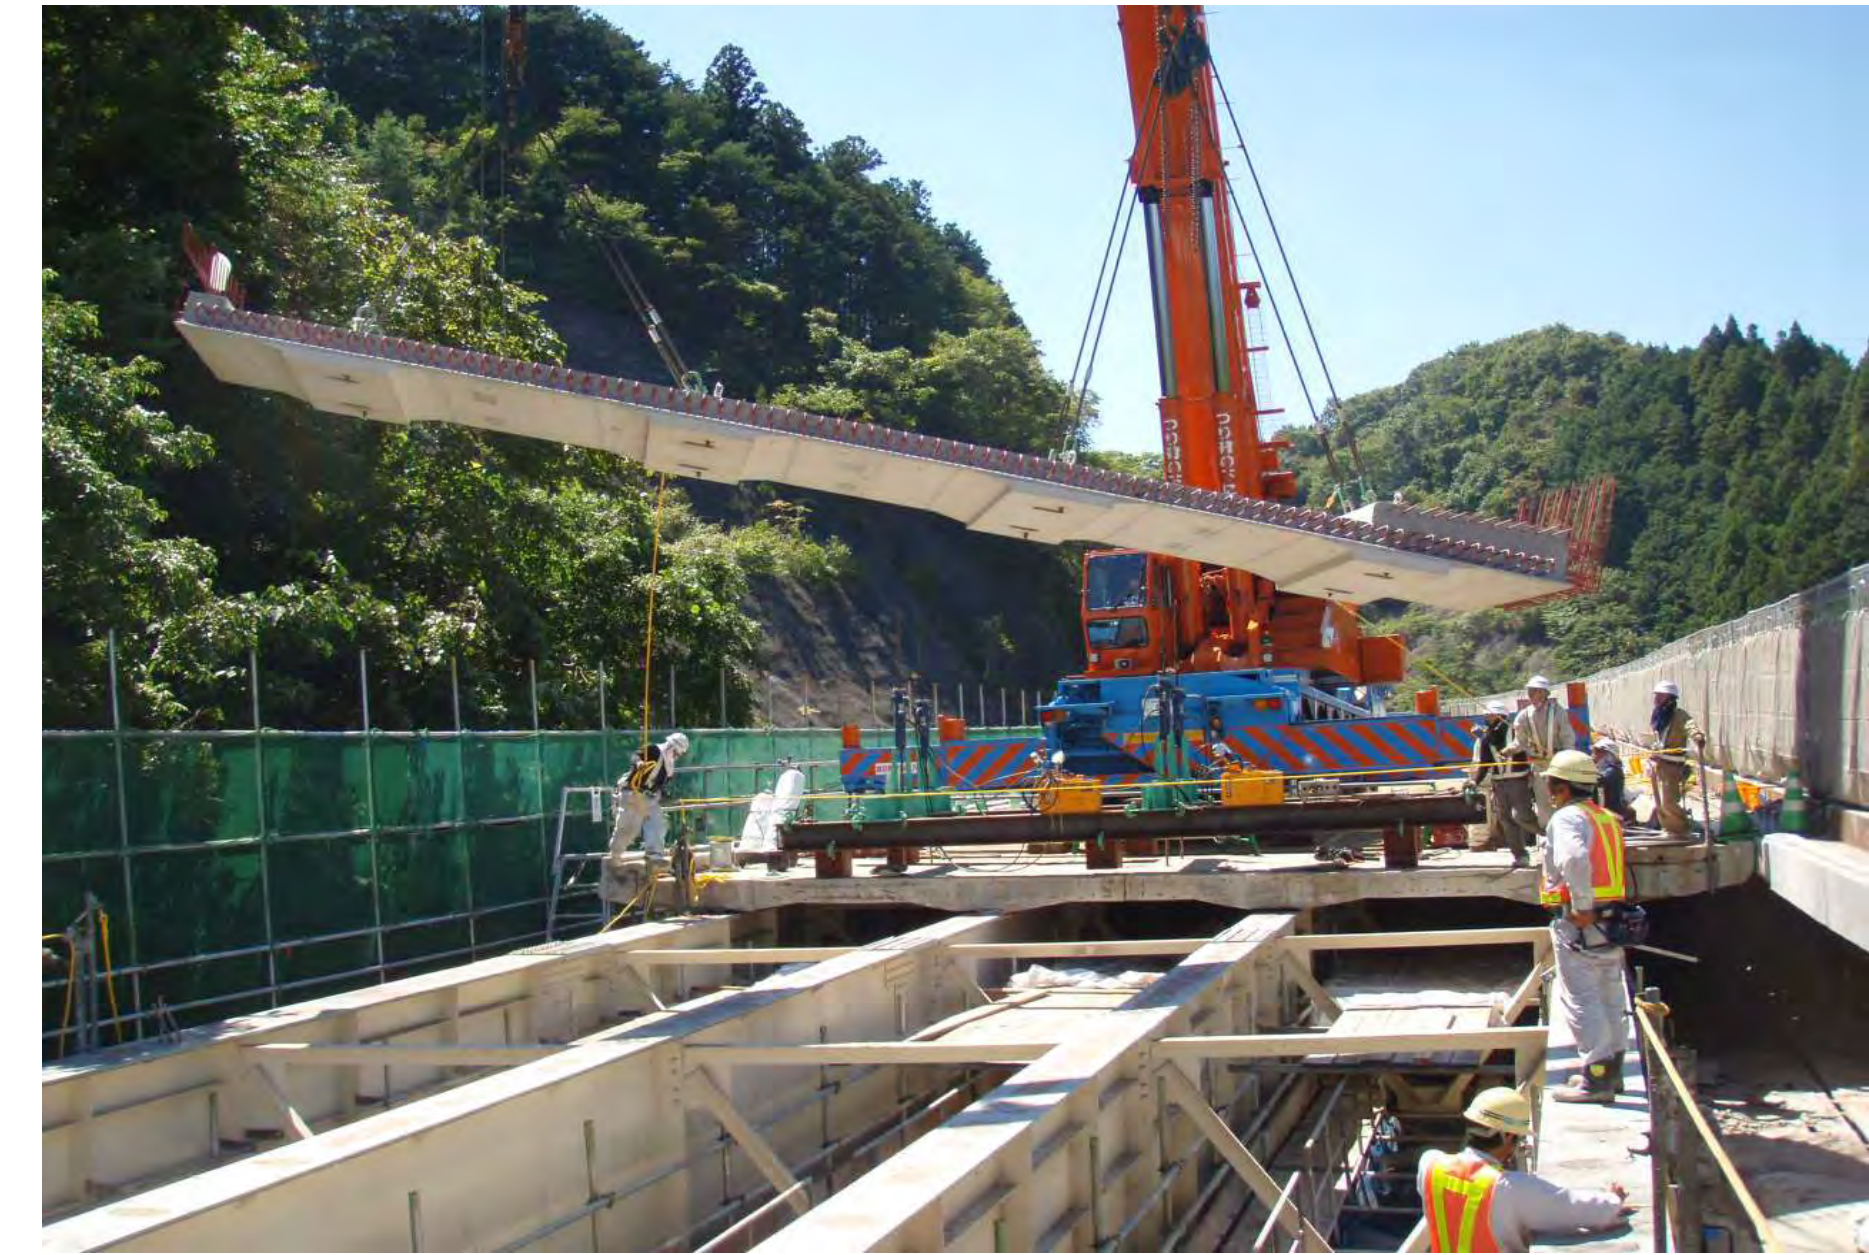
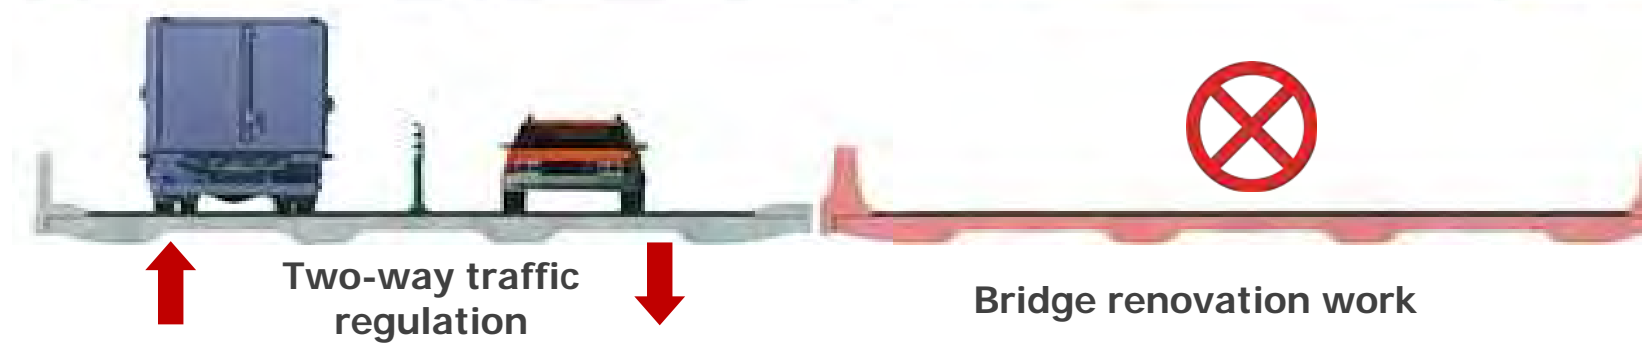
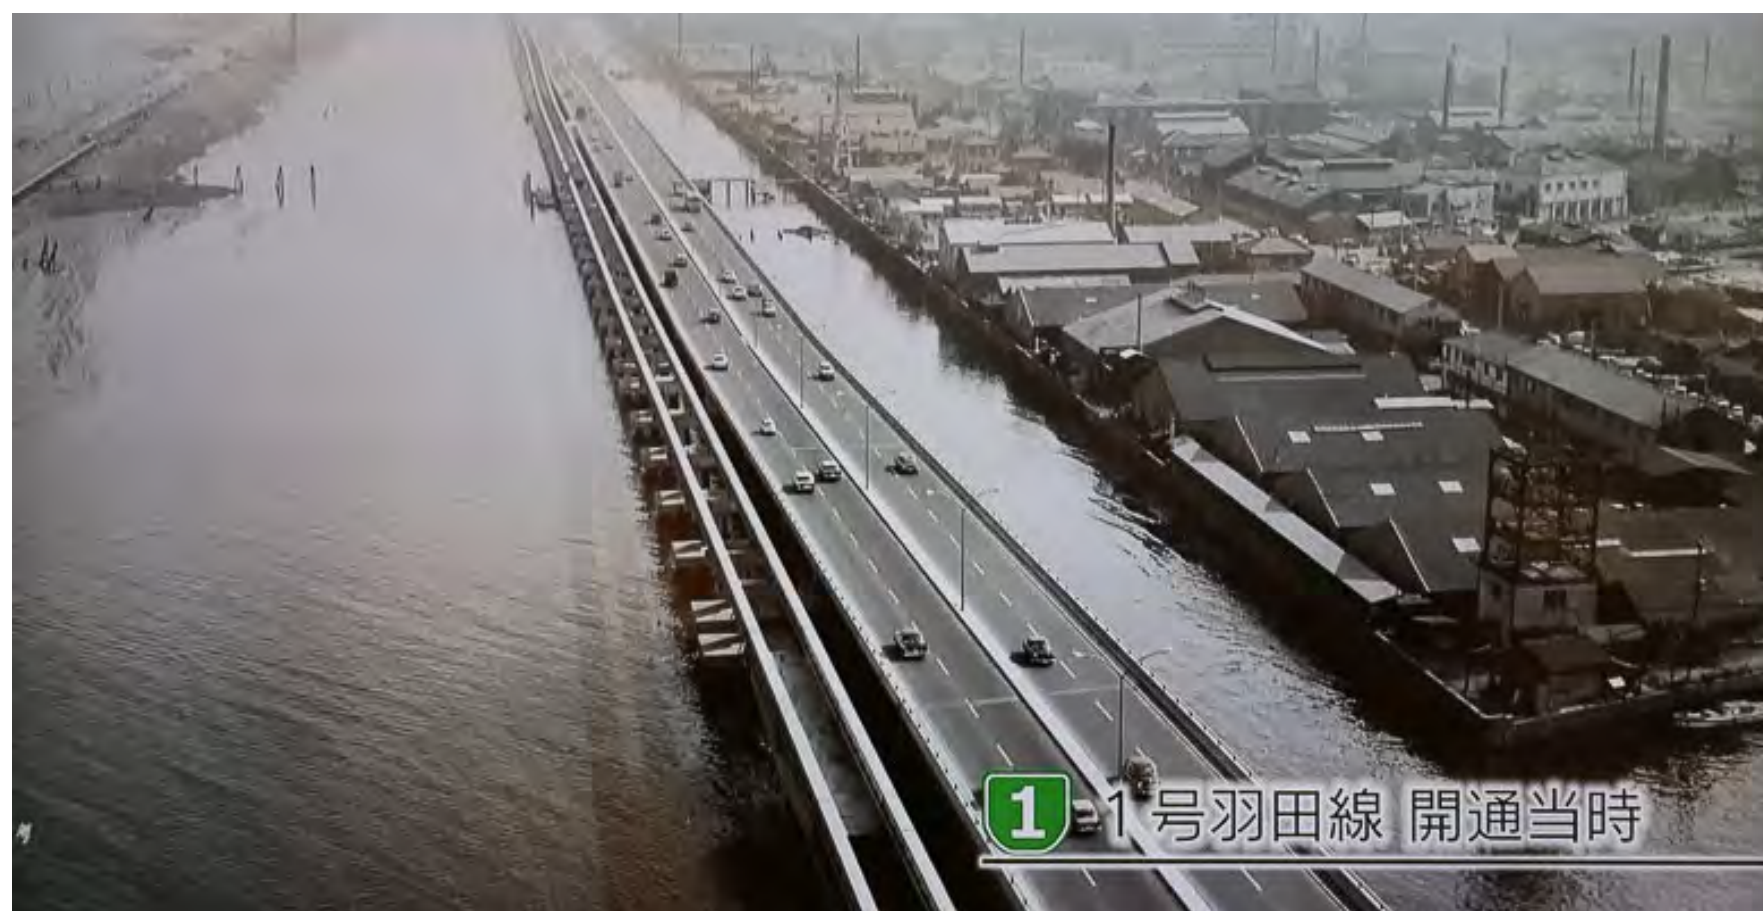
e.g. Replacement of RC concrete slab with PC precast slab

Open to Traffic (1963)

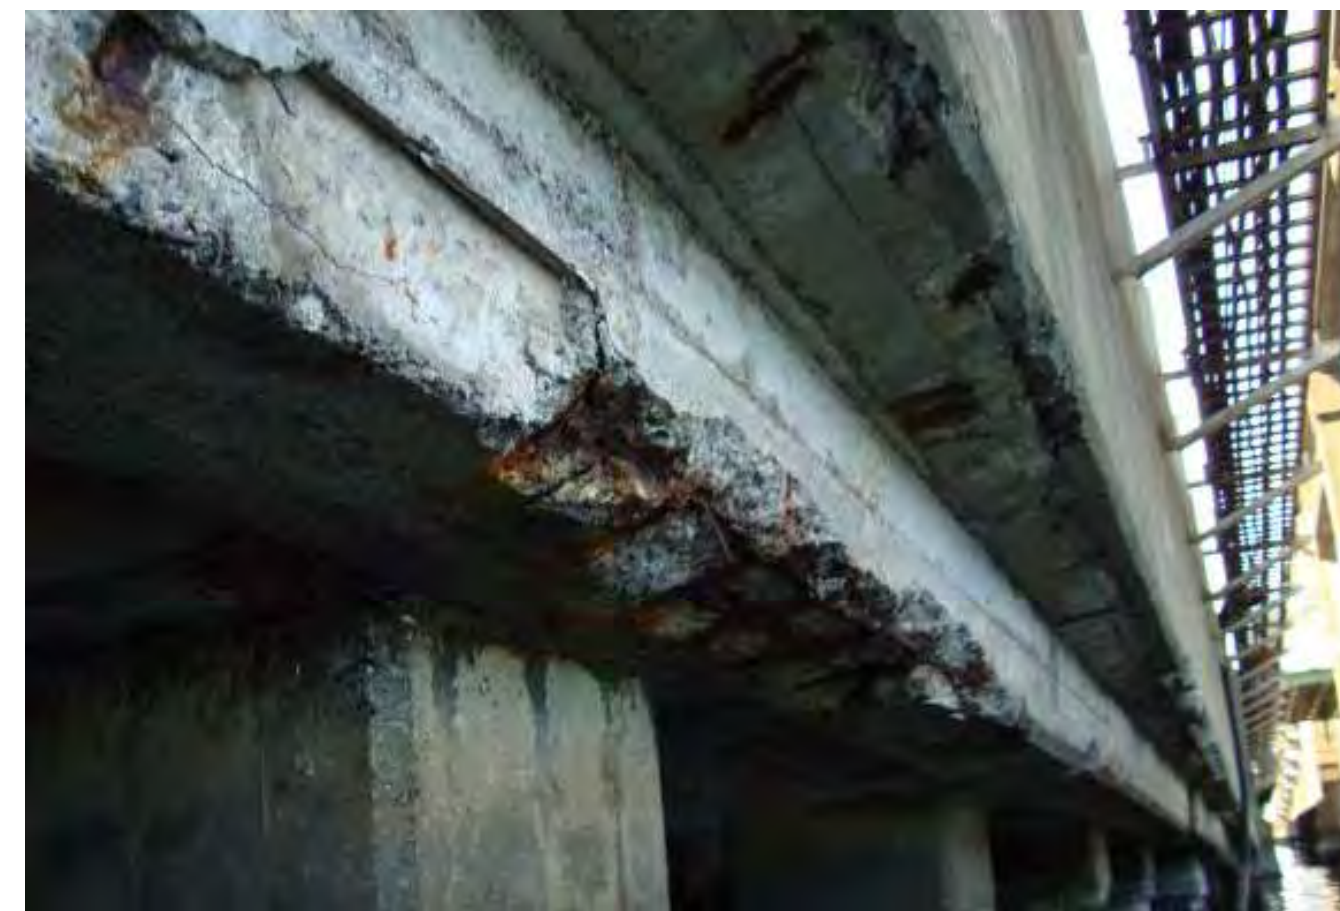
Deteriorated Structure (2014)

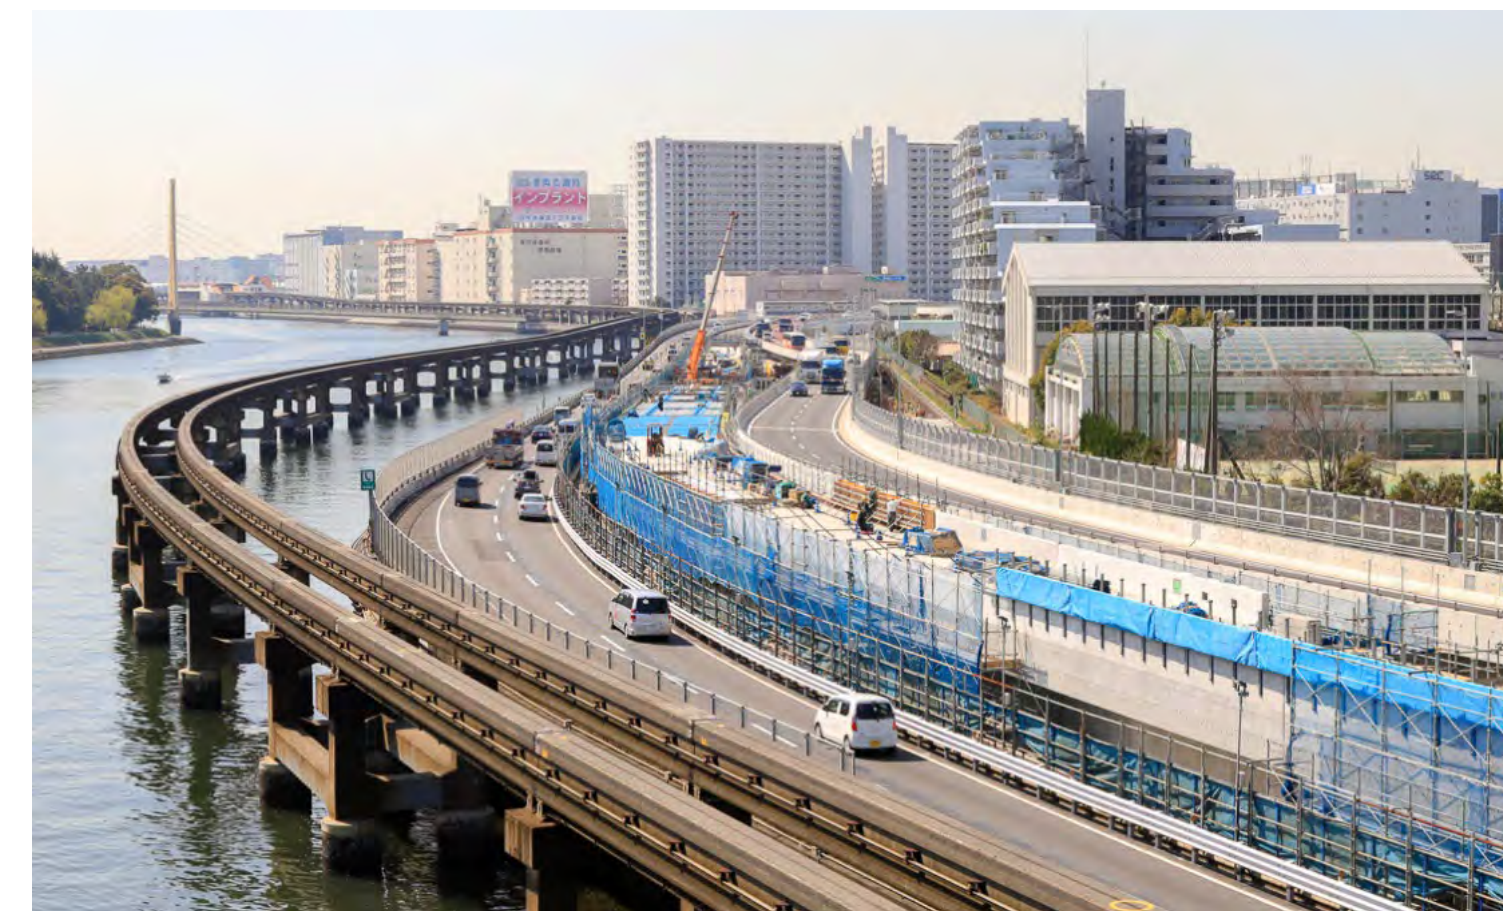
Undergoing Renewal Works (2019)

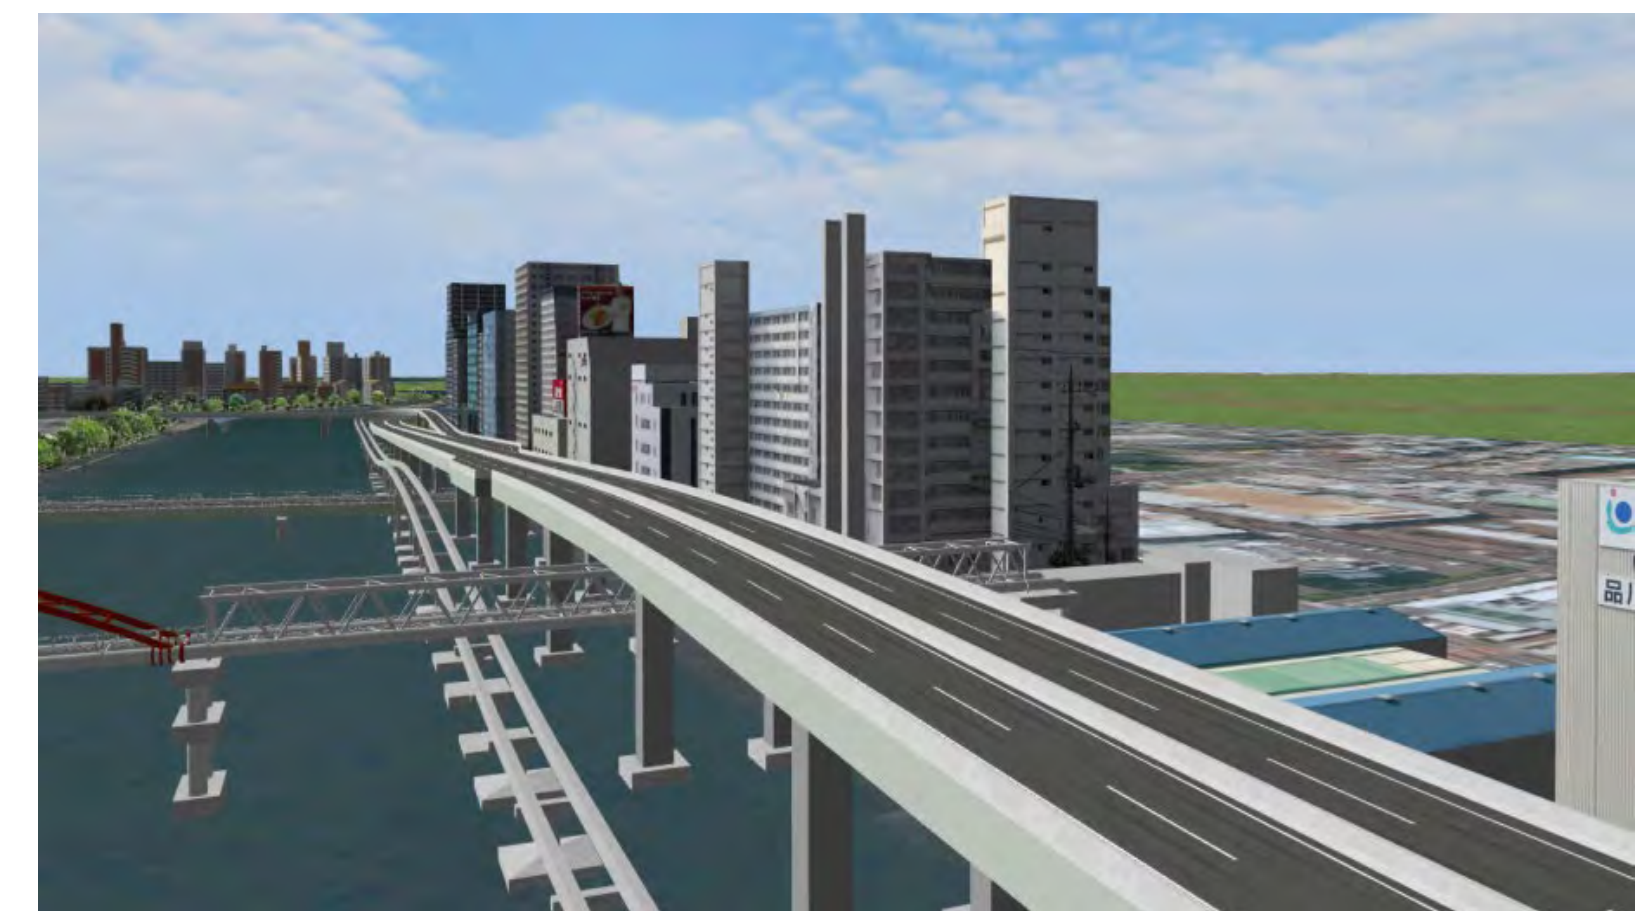
Renewed Segment (planned in 2026)

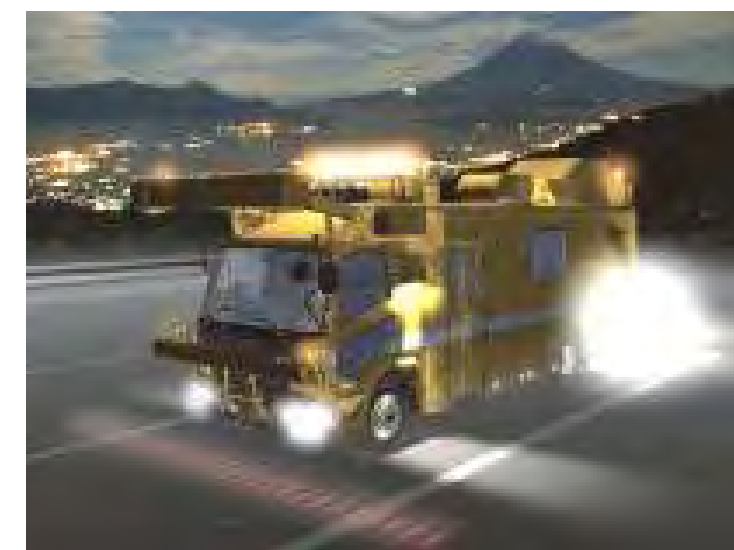
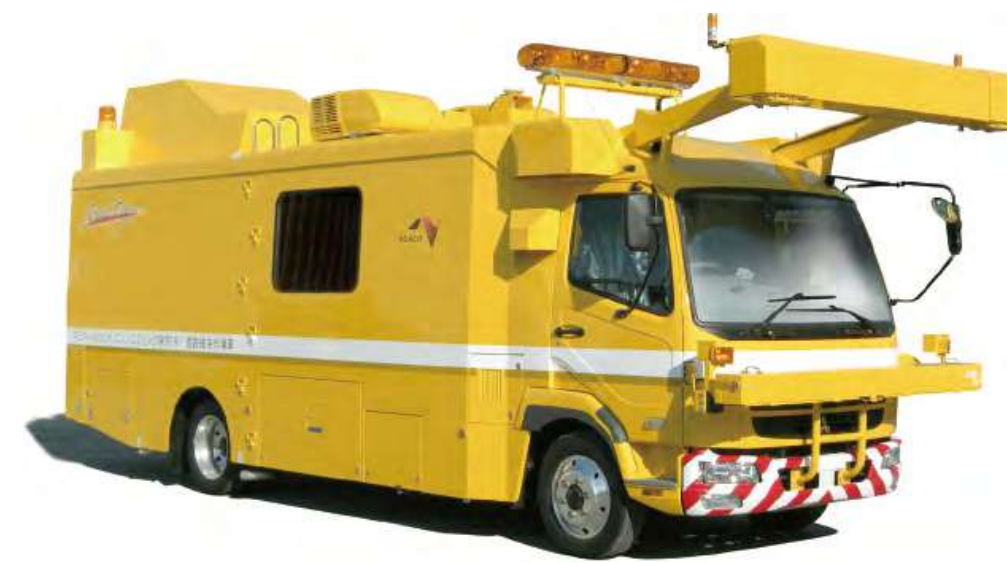
One of unique road surface inspection vehicles, not only can measure rutting, cracking, and flatness ( $\sigma_{10ft}$ , IRI) but also longitudinal and transverse pavement measurements without making contact with the pavement.

It can smoothly and safely perform all 6 functions at 100km/h without impacting the flow of other traffic.

High-Speed Road Surface Measuring Vehicle (Road Tiger)

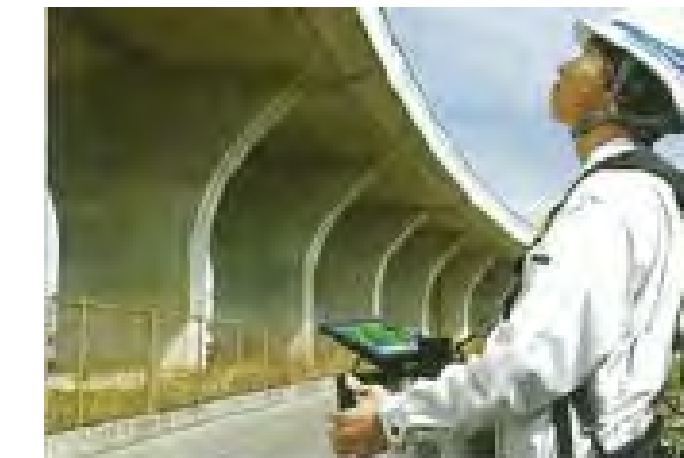
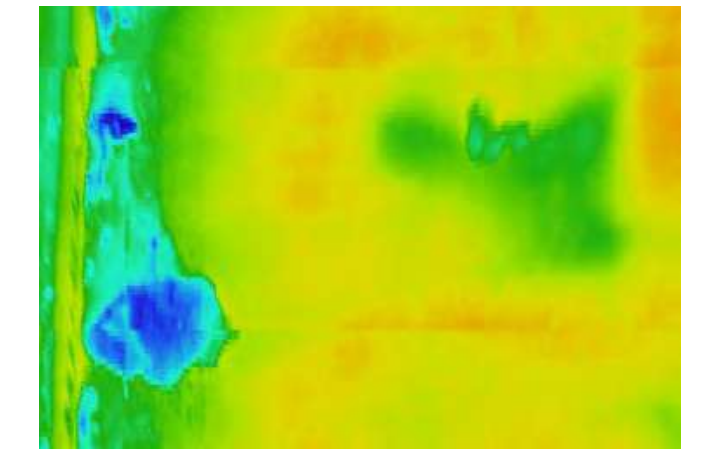
The infrared camera system takes images which is analyzed automatically and displays the damage level in three stages. Because damages are objectively analyzed by software, bias or oversight in measuring caused by skill difference can be prevented. In addition, this system helps to create a research report since the detected results are easily captured on spreadsheets or word processing software. This system has gotten track records in the U.S.

Infrared thermal image

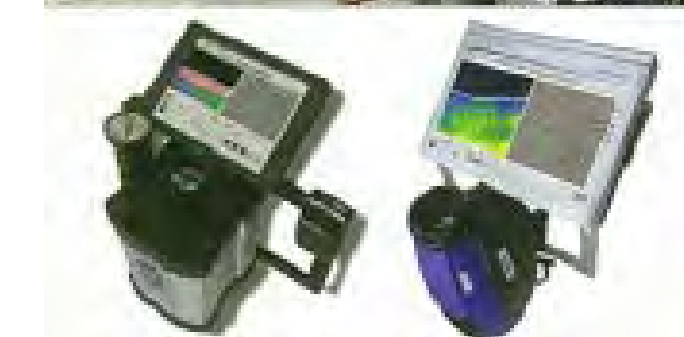
Bridge inspection using Infrared Camera System

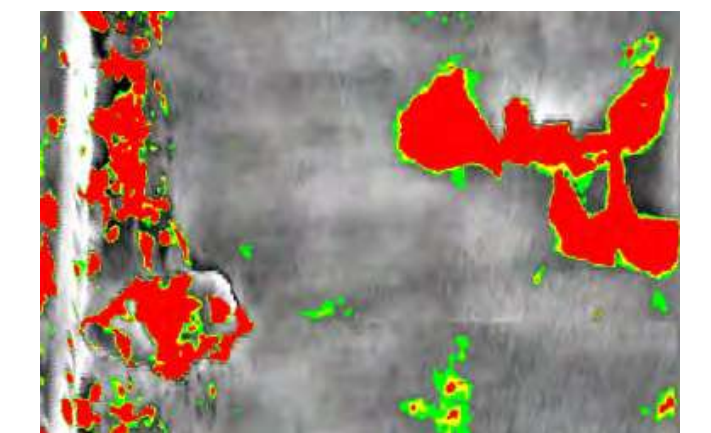
Damage is detected by computer analysis
