# Maintenance Technology of Honshu-Shikoku Bridges

-Long-span bridges for more than 200 years-

# Ageing Road Assets

# Expressway Renewal Project

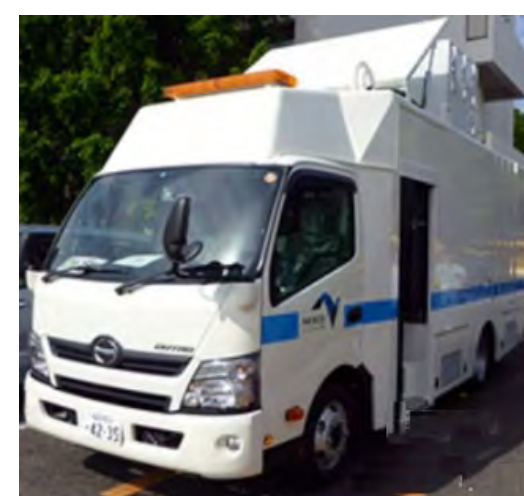
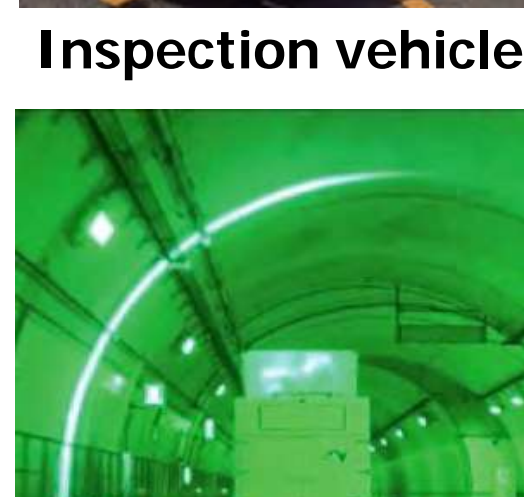
Filming in a tunnel

It is now possible to obtain a clearer image at a speed of 100km/h by adopting the line sensor camera instead of the conventional video camera. In addition, because the photographing illumination using LED infrared illumination is not visible to the naked eye, it no longer influences on the passing vehicles on the opposite direction. Moreover, this vehicle automatically identifies the cracks by the captured image.

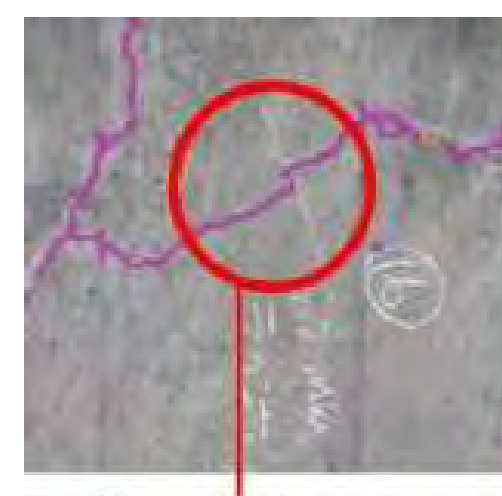
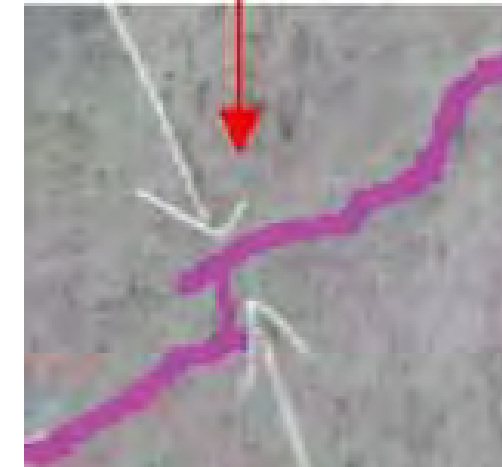
Crack analysis (minimum 0.2mm in width)

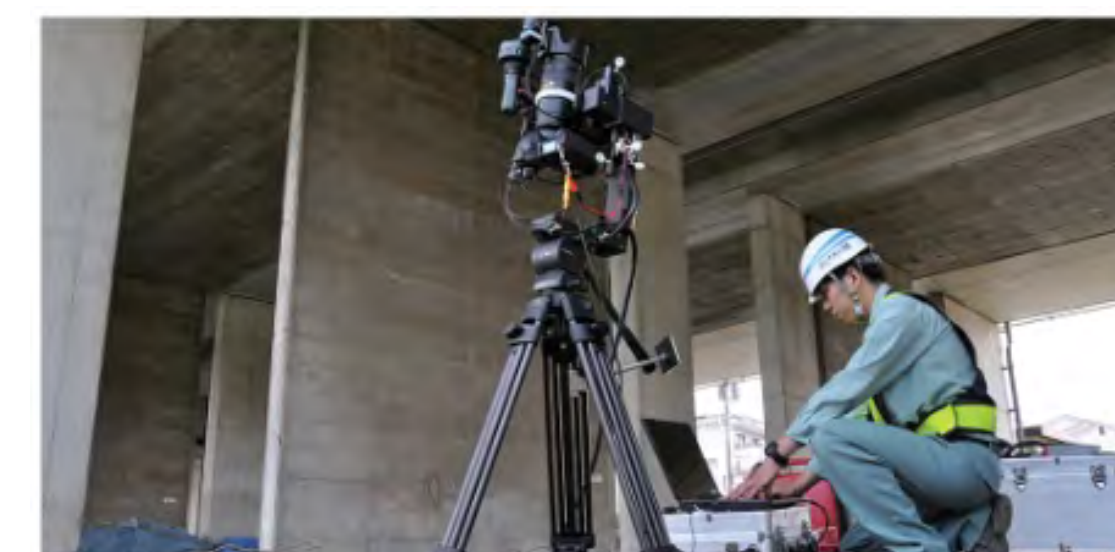
High definition images taken by digital camera or video camera makes it possible to inspect the surface of a structure in the same way as the close visual inspection.

Bridge inspection using Digital Camera System

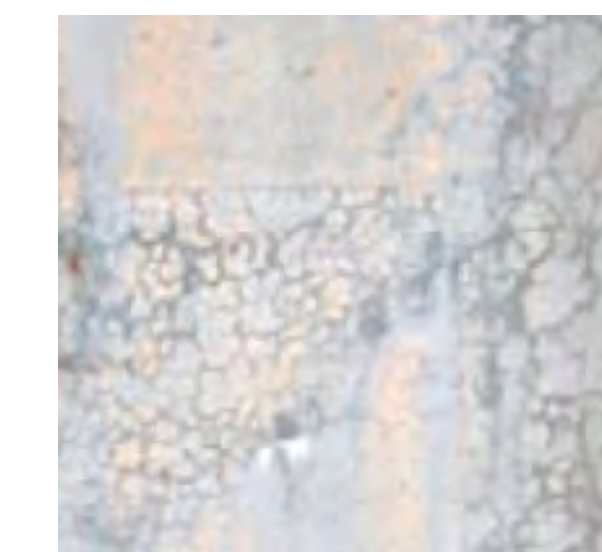
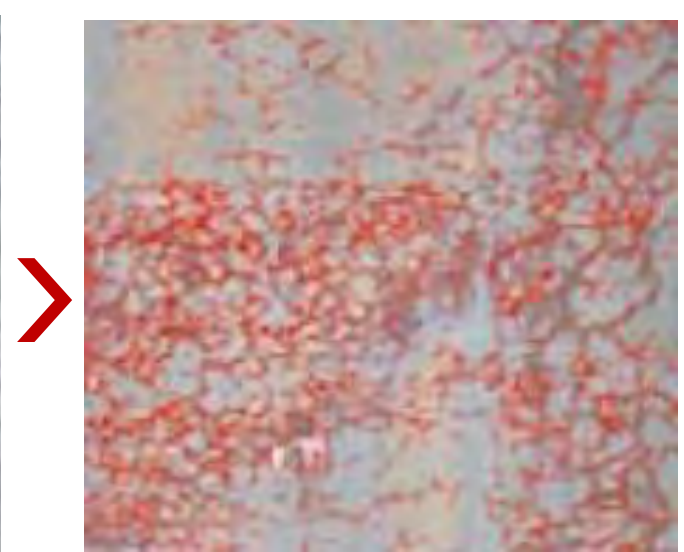
Through a computer analysis of the images, the cracks are automatically detected.

Automatic crack-analysis by computer

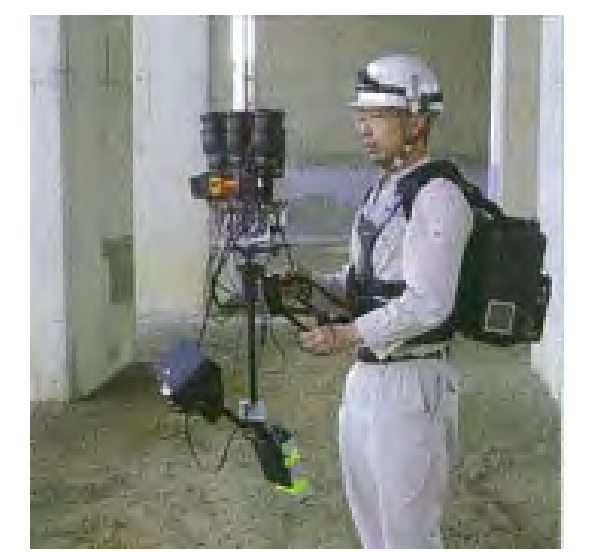
Video Camera System

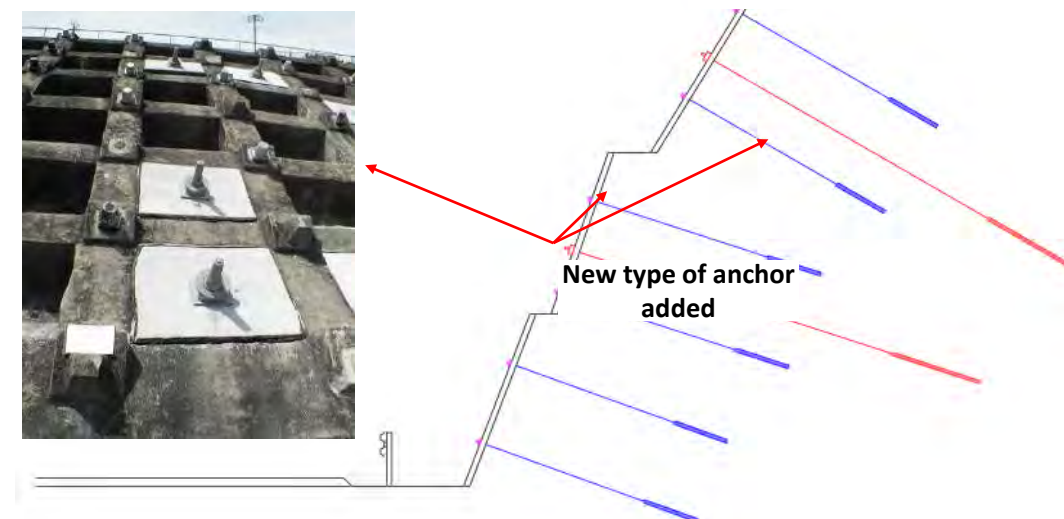
New type of anchor installation filling up traditional anchor with inadequate anticorrosion function

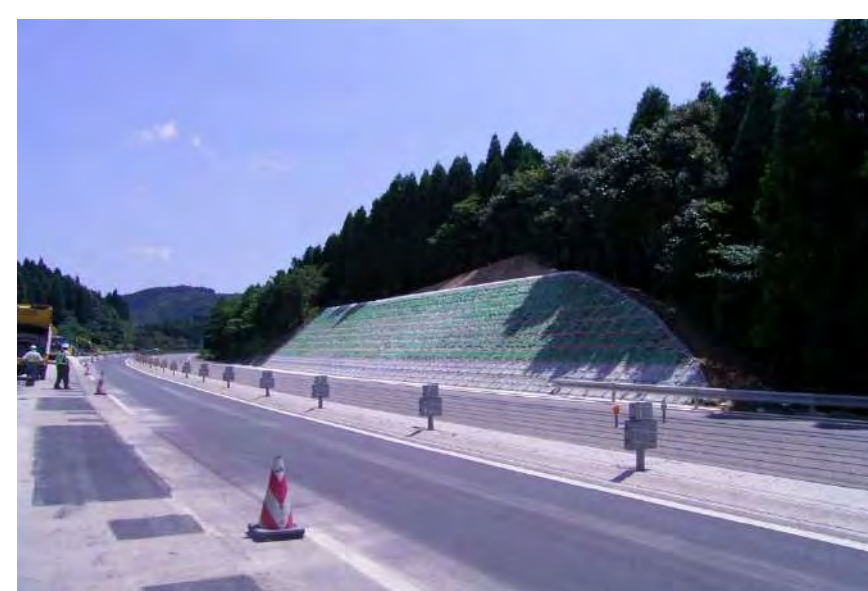
Measures against land slide
